—FAITH MINE

RE:
Prior Reclamation Inspections

**PRIOR RECLAMATION INSPECTION REPORT
AND
RECOMMENDATION FOR RELEASE OR PERMIT
REQUIREMENT**

Santa Fe Pacific Gold Corporation

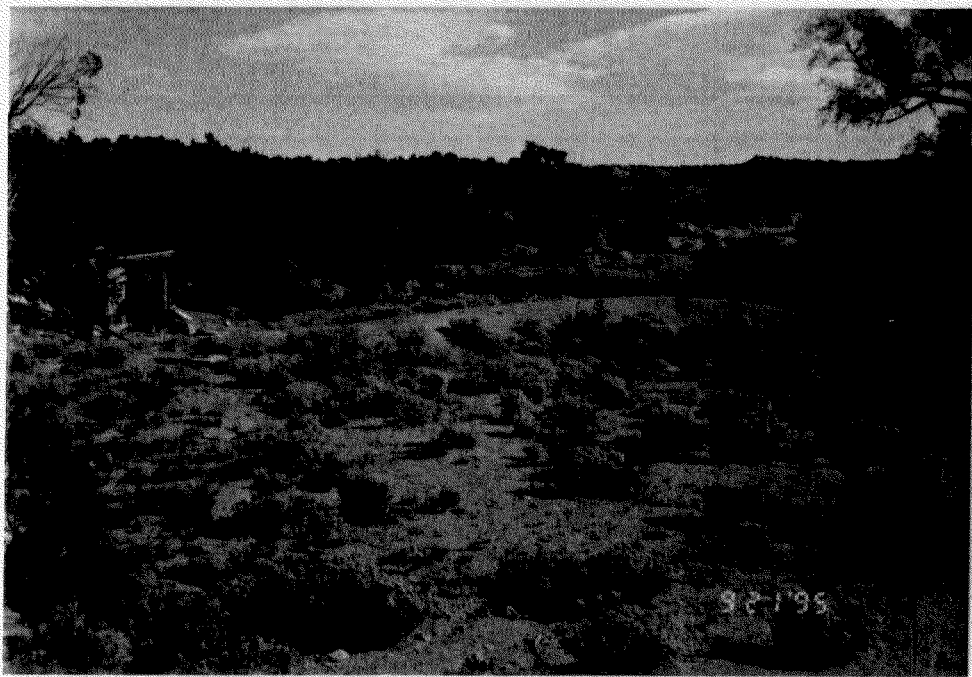
Section 13 T1N R6W, Powder Magazine, September 21, 1995

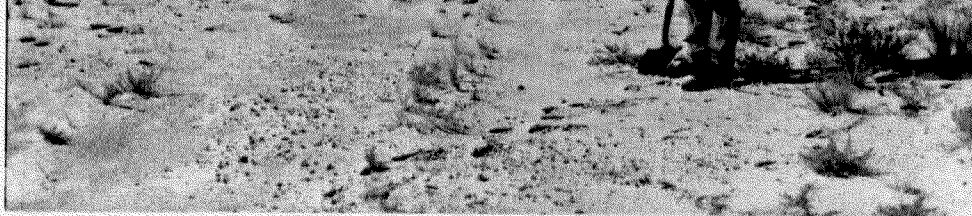
This mine site is located on a shelf in a canyon wall about 50 feet above the canyon floor. The canyon was eroded into Dakota Sandstone. The mine had been operated by Kerr-McGee under a lease agreement with Santa Fe Pacific Gold and was safeguarded by Kerr-McGee upon termination of that agreement (Santa Fe, 1994). All structures, trash or junk had been removed from the site. There were no piles or accumulations of toxic or waste material on the site. A vertical shaft had been backfilled with nontoxic mine waste material.

Essentially, the site had been safeguarded but not topsoiled or reseeded. The site is characterized by white fine grained sandstone covered by a few inches of fine white sand. The sand is subsequently being eroded away by wind and water. A mine access road had significant erosion. An impoundment had been constructed to impound sediment from the mine site, however, erosion from the access road was bypassing the impoundment and was entering the mine site. Photographs documenting vegetation and the general condition of the site are presented in Appendix C.

Section 1 T13N R9W, Shaft Site looking South, 9/13/95

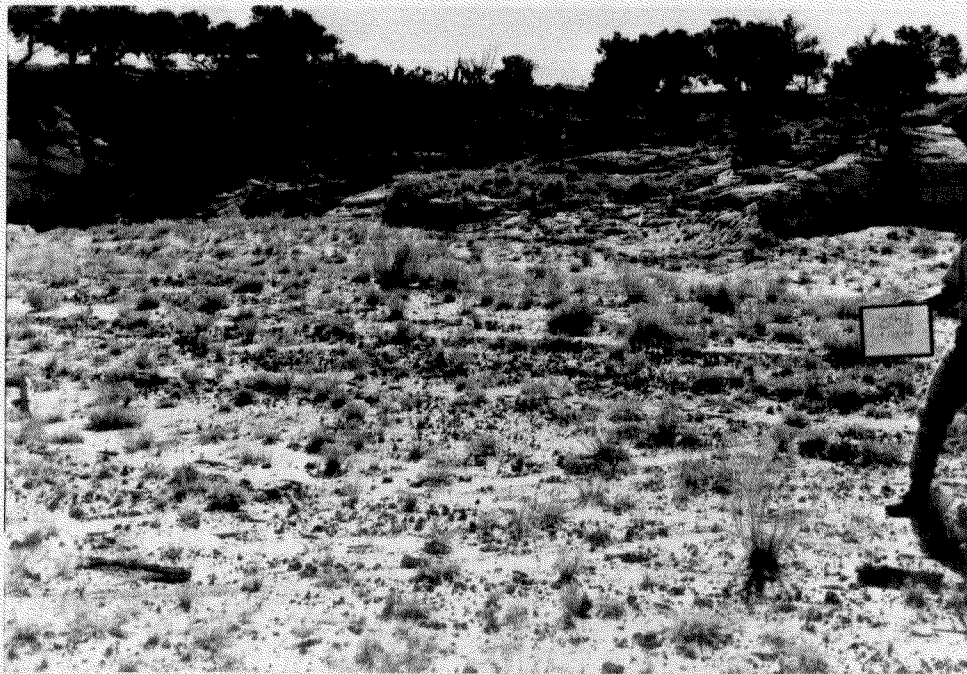
Section 1 T13N R9W, Shaft Site Looking West, 9/13/95

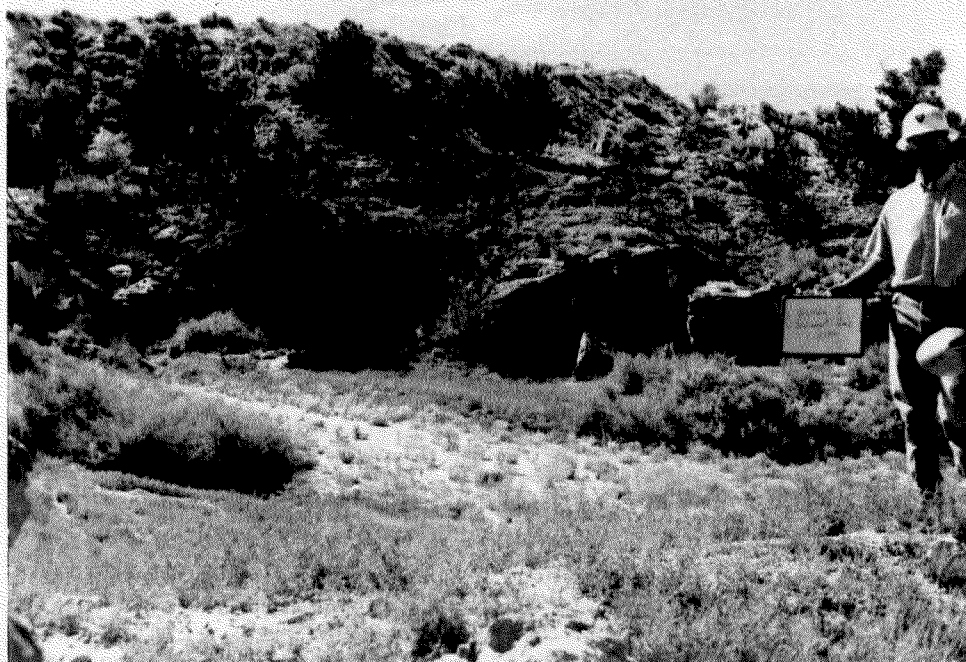
Section 1 T13N R9W, Sediment Pond, 9/13/95

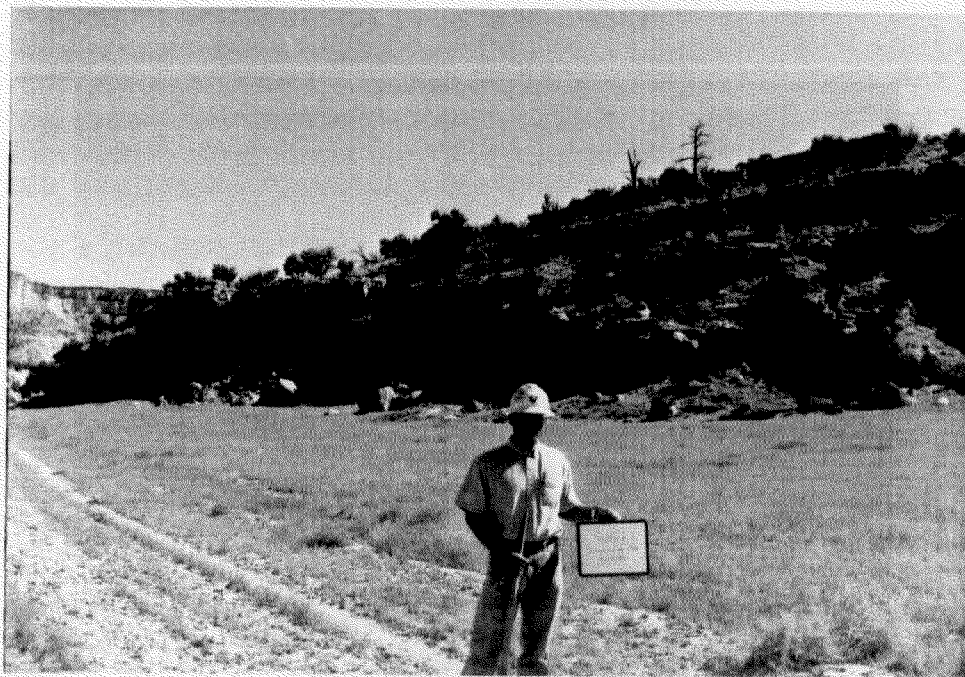
Section 1 T13N R9W, Looking Up at Mine Site, 9/13/95

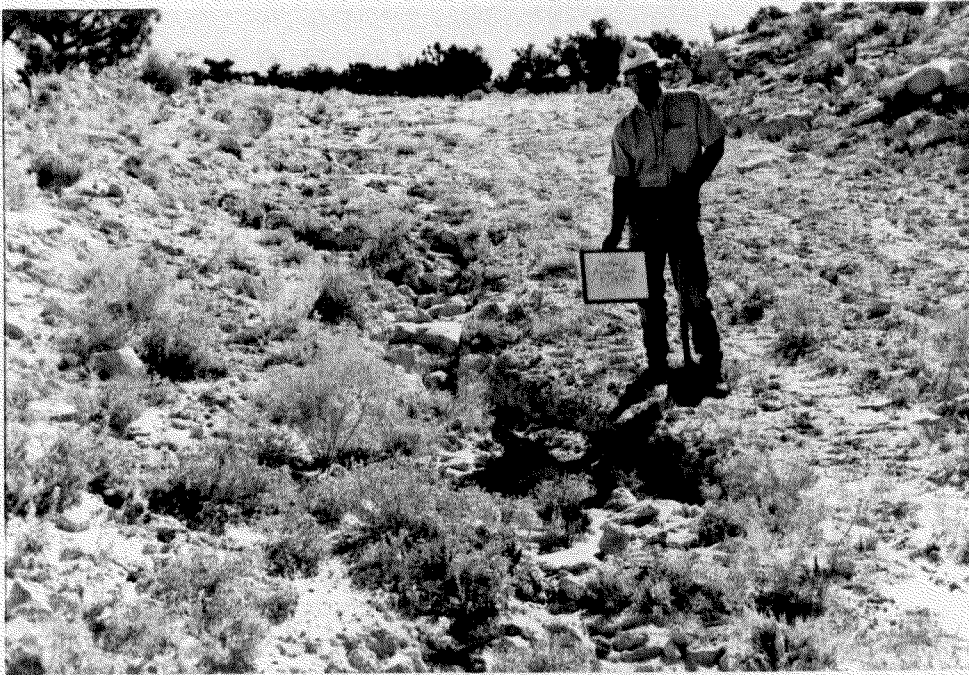
Section 1 T13N R9W, Access Road, 9/13/95

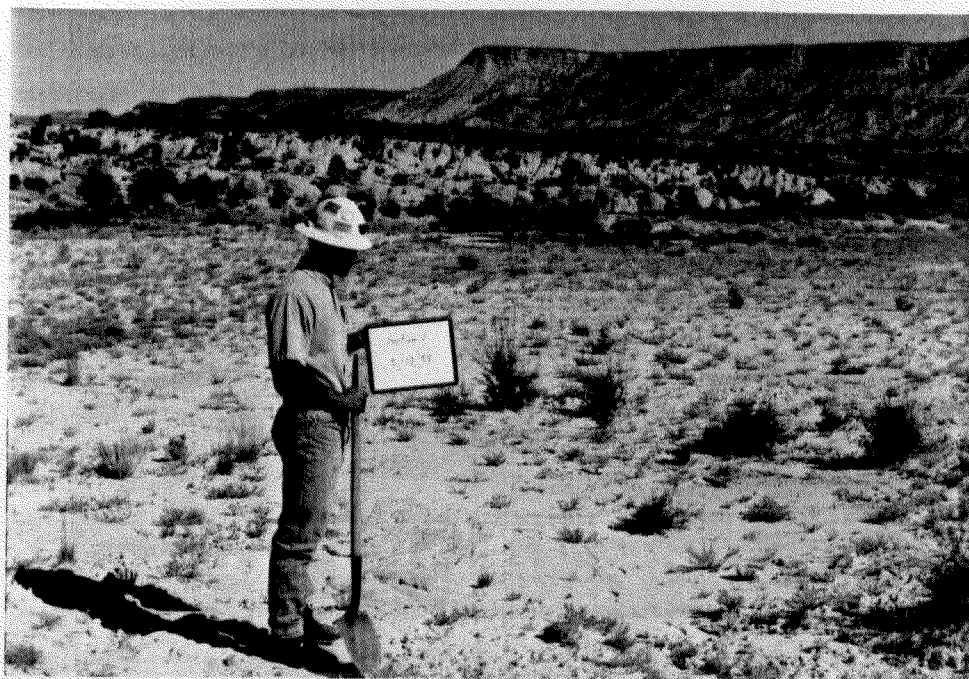
Section 1 T13N R9W, South Side Looking North, 9/13/95

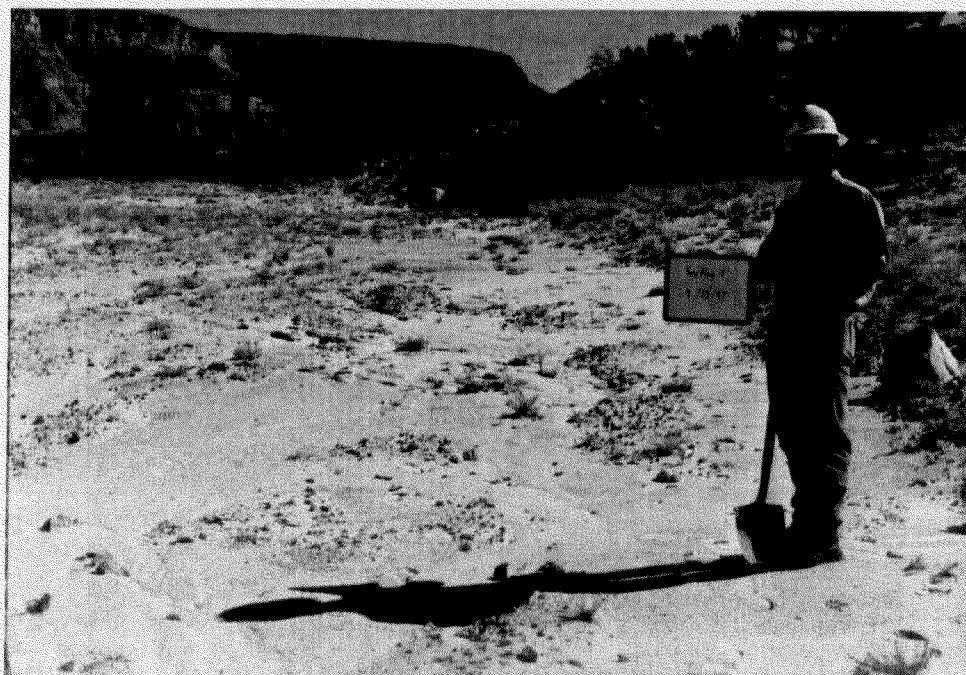
Section 1 T13N R9W, North Side Looking South, 9/13/95

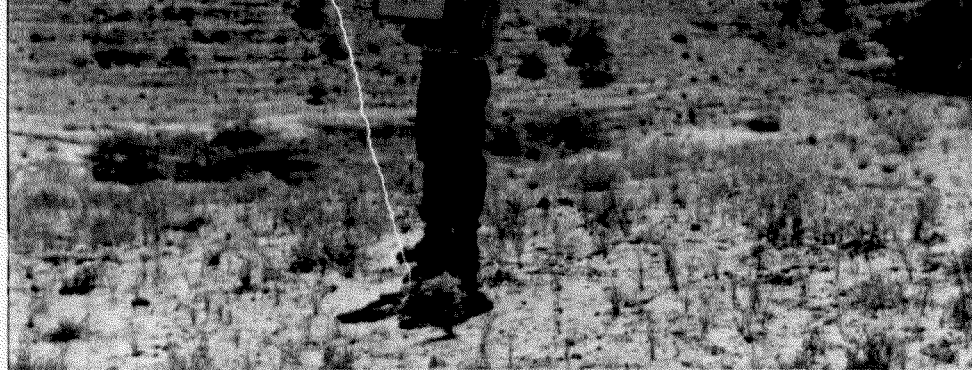
Portions of the reclaimed vegetation have heavily grazed by wildlife and domestic livestock. However, native plant species were invading the area. Twenty-six native species of plants were identified. Line-intercept transects showed average perennial vegetation cover to be approximately 22 percent (Young, 1995). Vegetation measurements are presented in Table V. Despite the slight increase in the number of perennial species invading this site from adjacent areas, there was poor establishment of the perennial grasses, forbs, and shrubs on the slopes of the depressions and topsoil mounds. Because of the lack of adequate cover, this site does not qualify for release at this time.

Section 25 Mine, West Side Looking West, 9/12/95

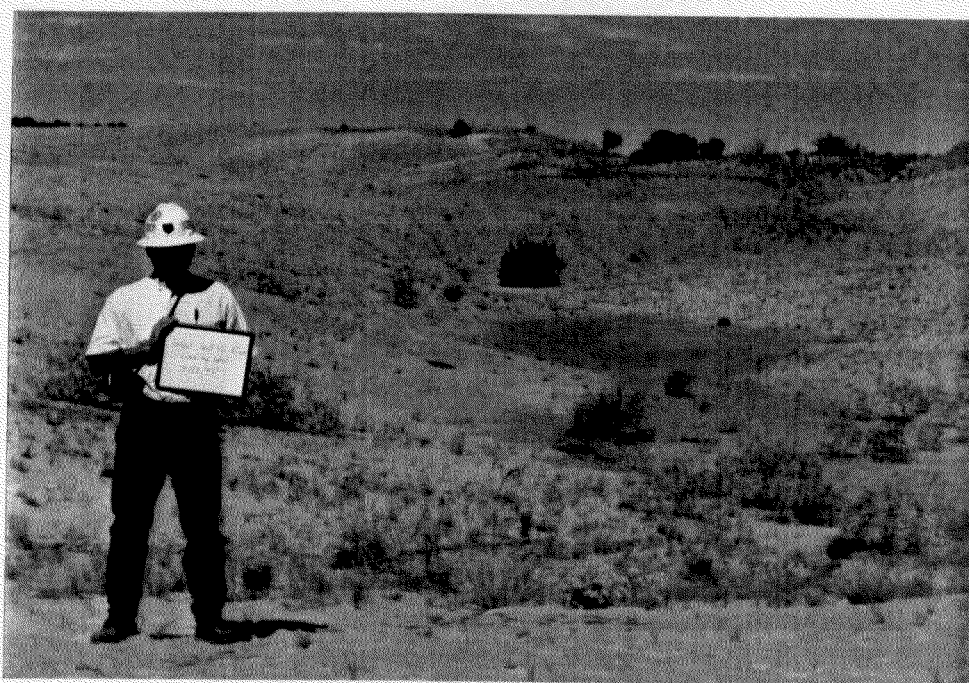
Section 25 Mine, Middle Looking East, 9/12/95

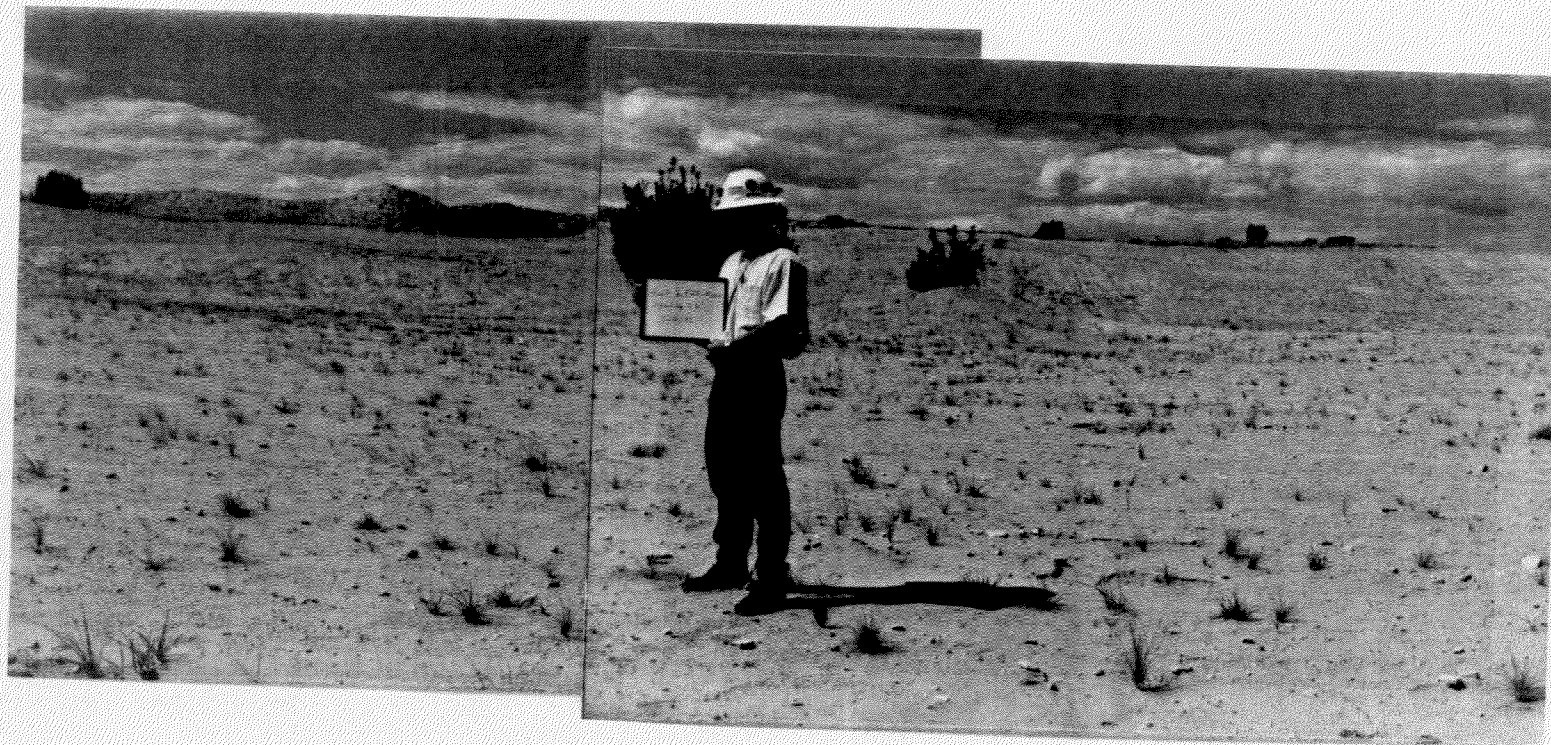
Section 25 Mine, East Side Looking Southwest, 9/12/95

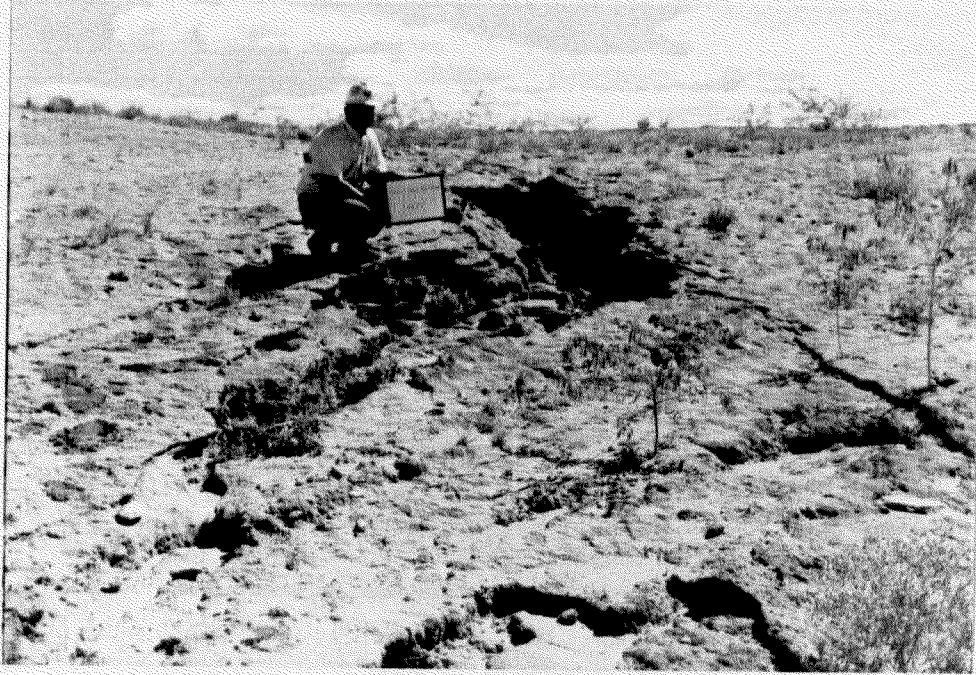
Section 25 Mine, Erosion Feature, 9/12/95

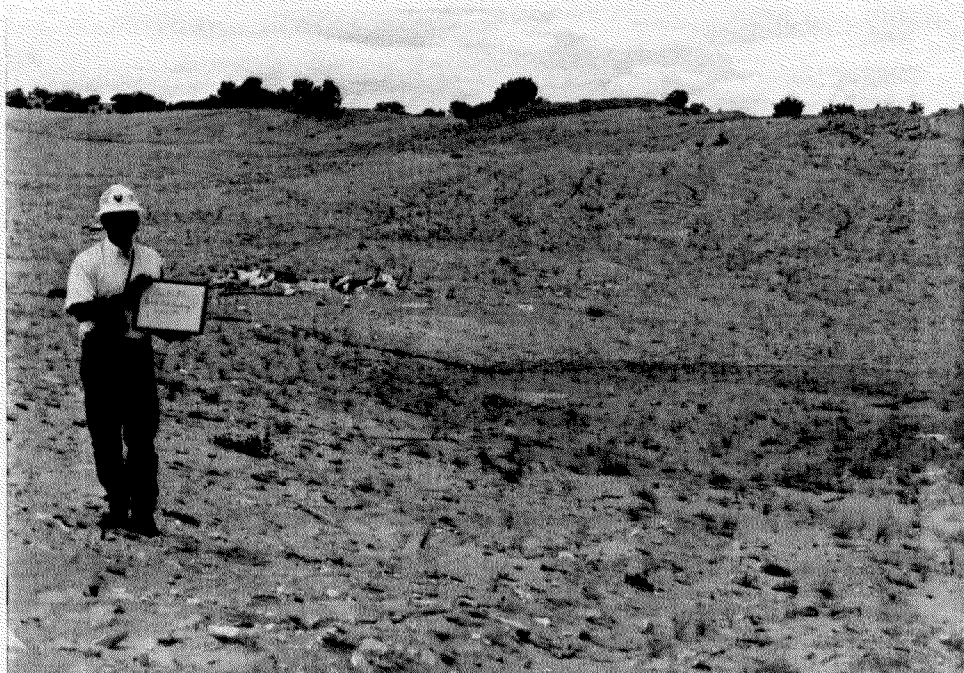
There was evidence of grazing by livestock and wildlife on this site. Vegetation also showed signs of drought stress. Line-intercept transects showed vegetation cover to be approximately 12 percent (Young, 1995). The results of these vegetation measurements are presented in Table VI. Because of the lack of cover and diversity, staff does not recommend this site for release.

Section 31 T13N R9W, North End Looking South, 9/12/95

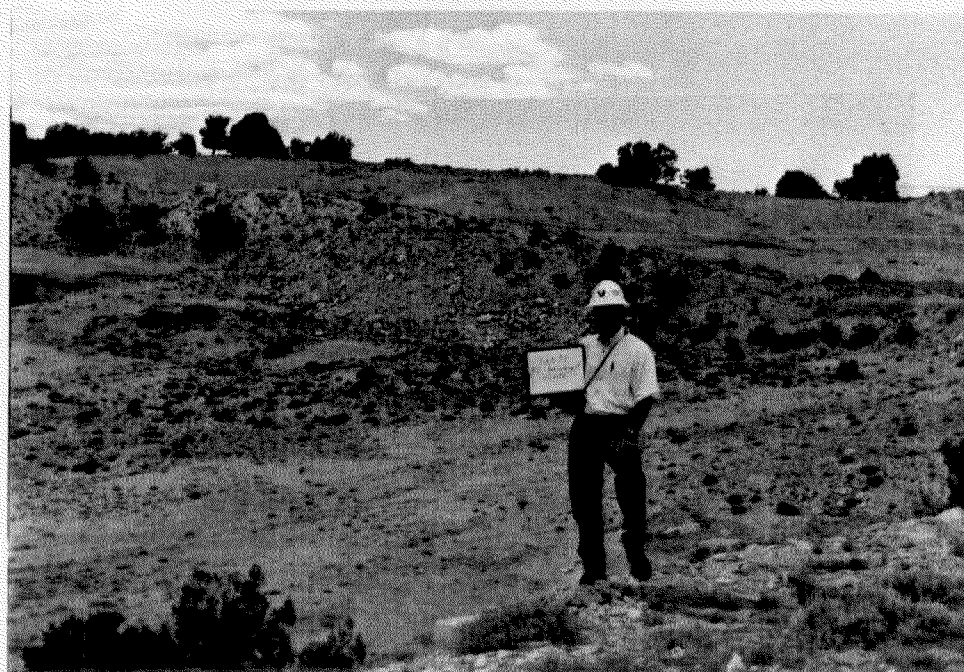
Section 31 T13N R9W, Northeast Side Looking West, 9/12/95

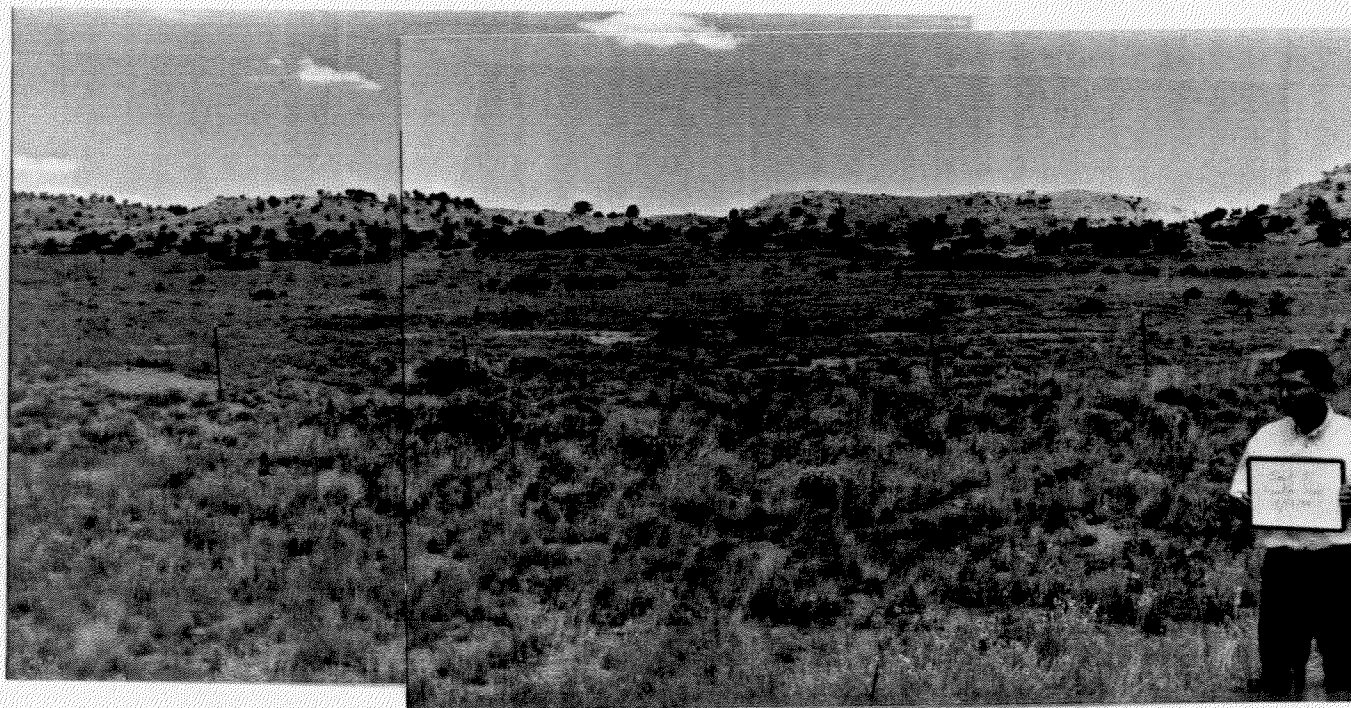
Section 31 T13N R9W, Reconstructed Limestone Bluffs, 9/12/95

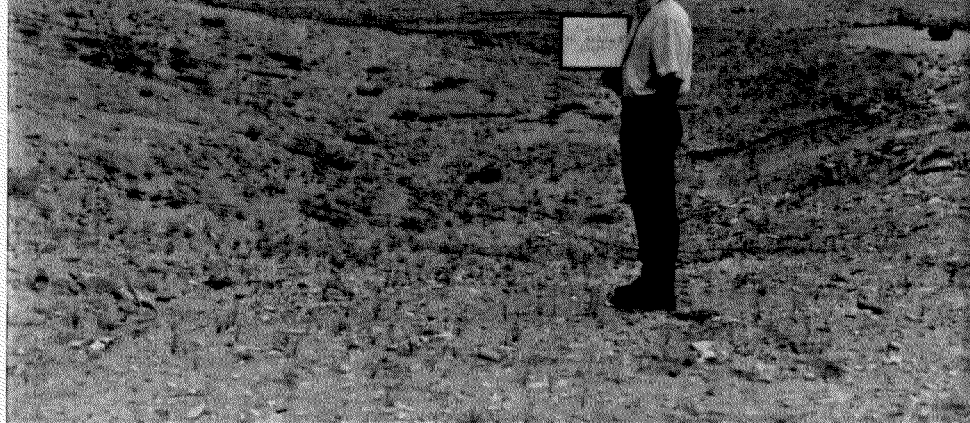
Section 31 T13N R9W, Southeast Side looking North

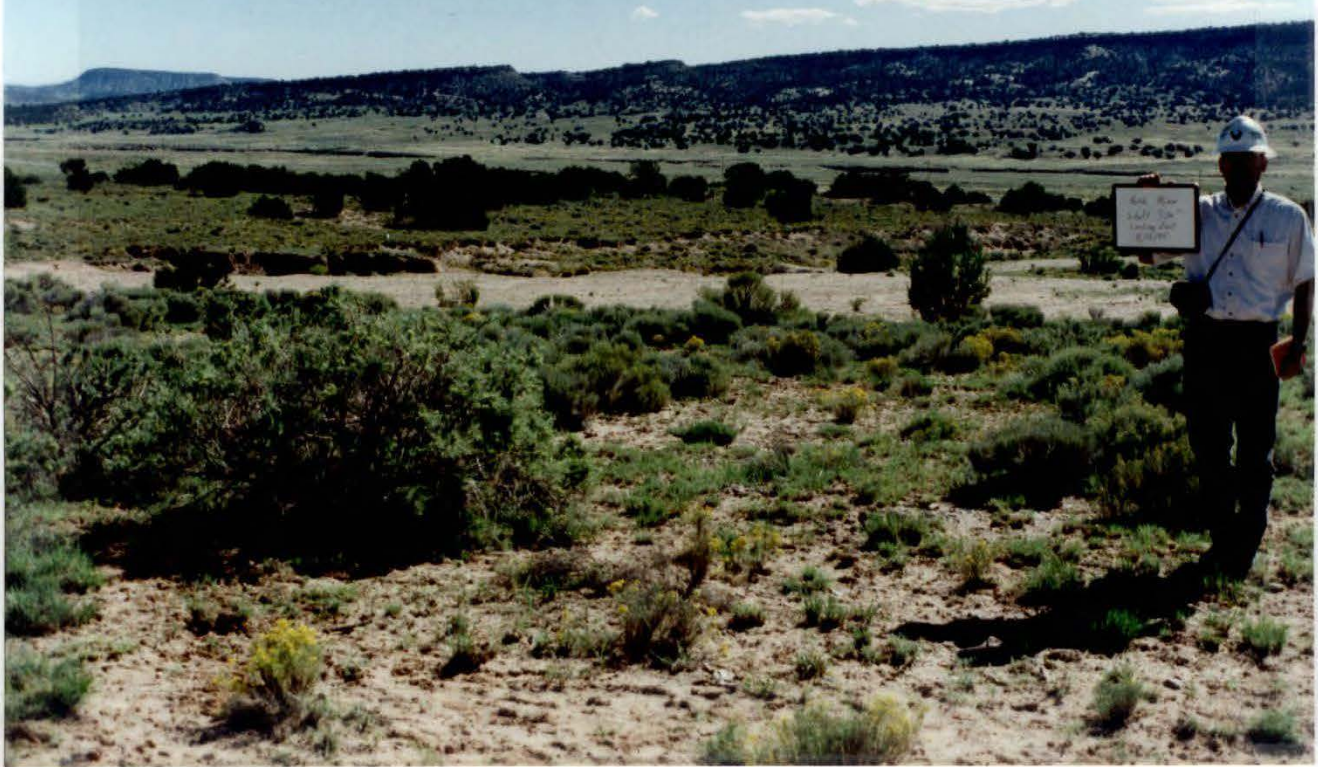
This underground mine was reclaimed in 1986 (Eby, 1995). Native vegetation from adjoining undisturbed lands had invaded the site and it was difficult to tell that a mine had previously existed on this site. Approximately one acre had recently been regraded and reclaimed, the only other indication of the mine presence was a revegetated mound where a vertical shaft had been backfilled with nontoxic mine waste material (Eby, 1995). All structures, trash or junk had been removed from the site. There were no piles or accumulations of toxic or waste material on the site. Similarly, there were no erosion features. Photographs documenting vegetation and general condition of the site are presented in Appendix H. Topsoil depths across the site ranged from 4 to 6 inches.

As with the other mines, the vegetation had been grazed by wildlife and domestic livestock. The vegetation also showed signs of drought stress. However, the adequate plant cover and diversity deemed it unnecessary to perform transect evaluations of the plant community. Staff recommends this site of release. The plant

Faith Mine Shaft Site, Looking East, 9/12/95
Regraded Area in Background

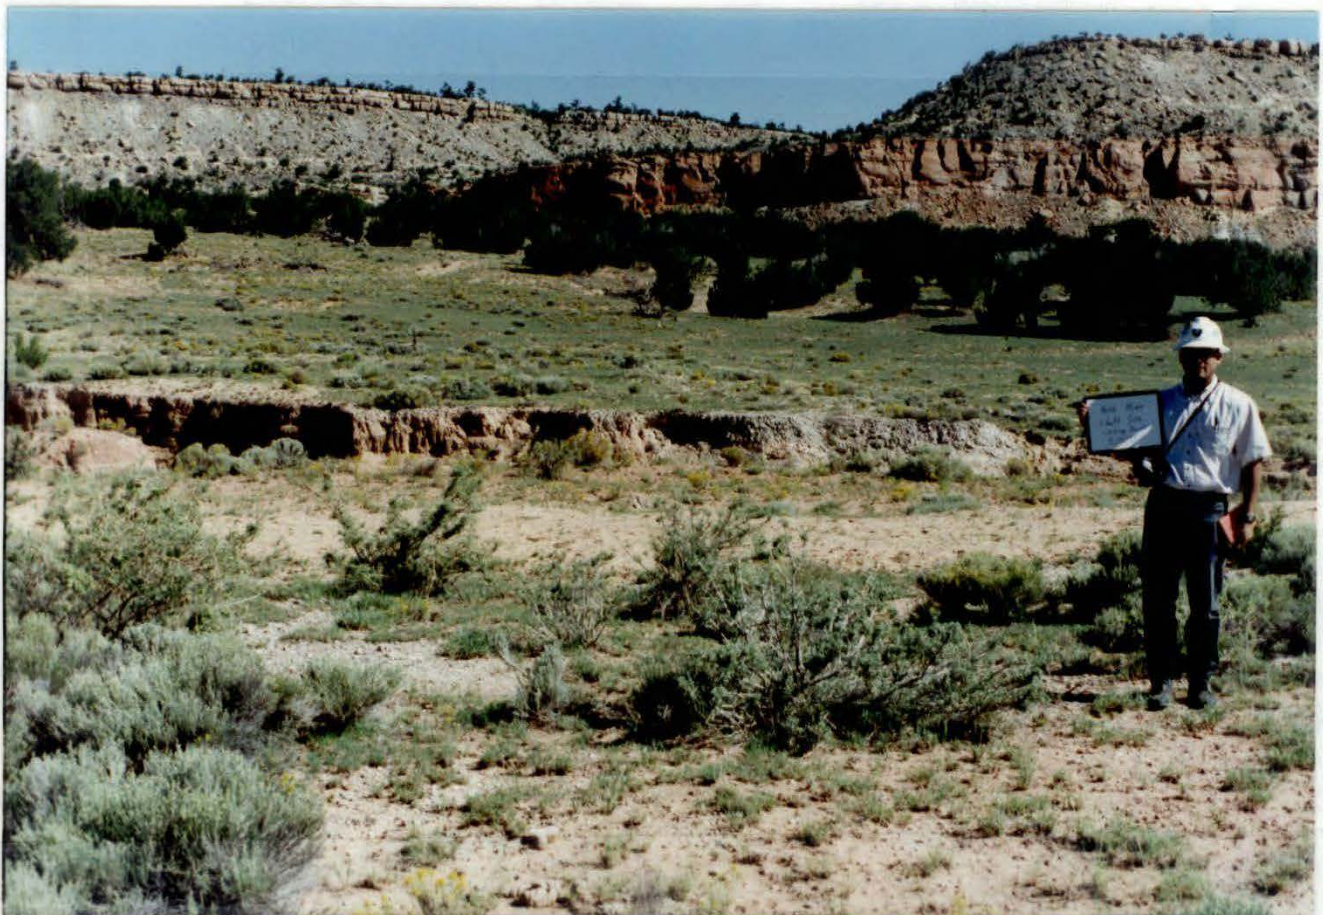
Faith Mine Shaft Site, Looking North, 9/12/95

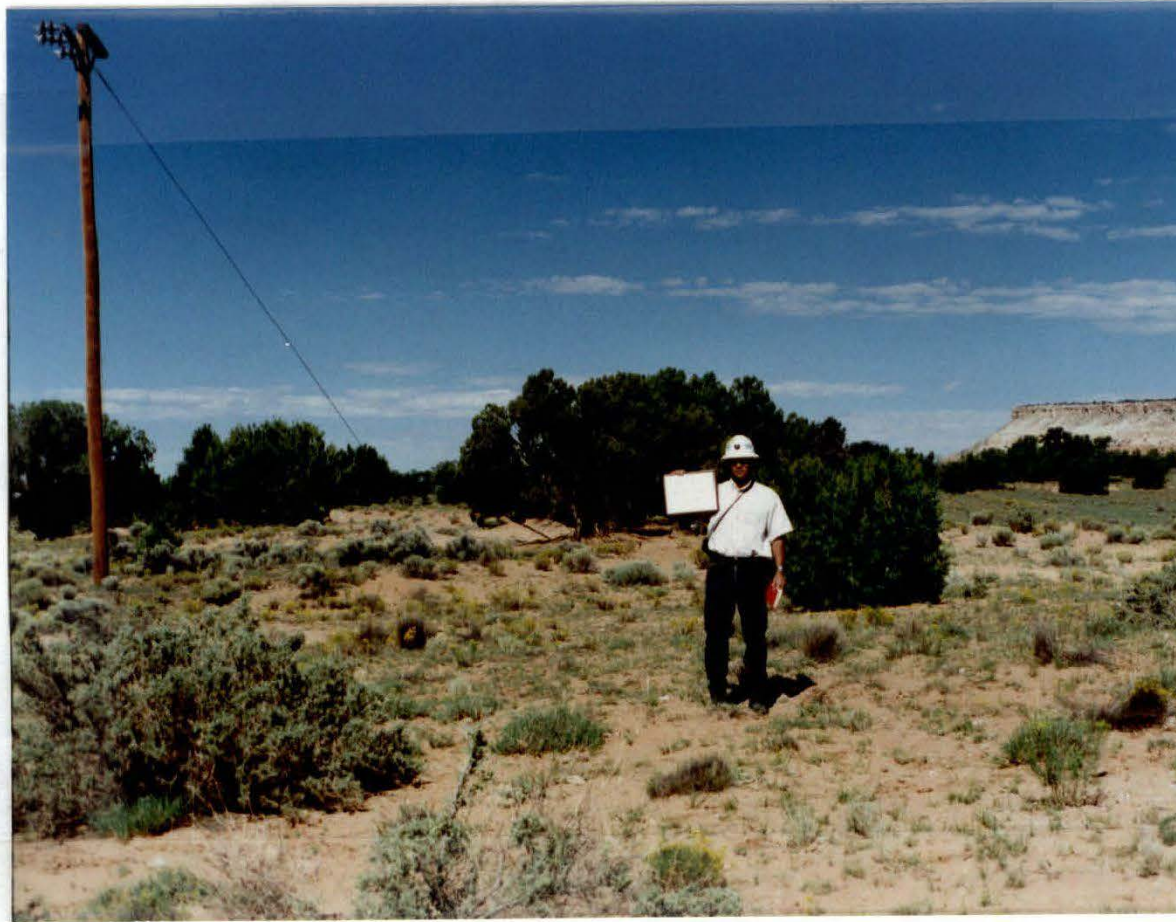
Faith Mine Shaft Site, Looking West, 9/12/95

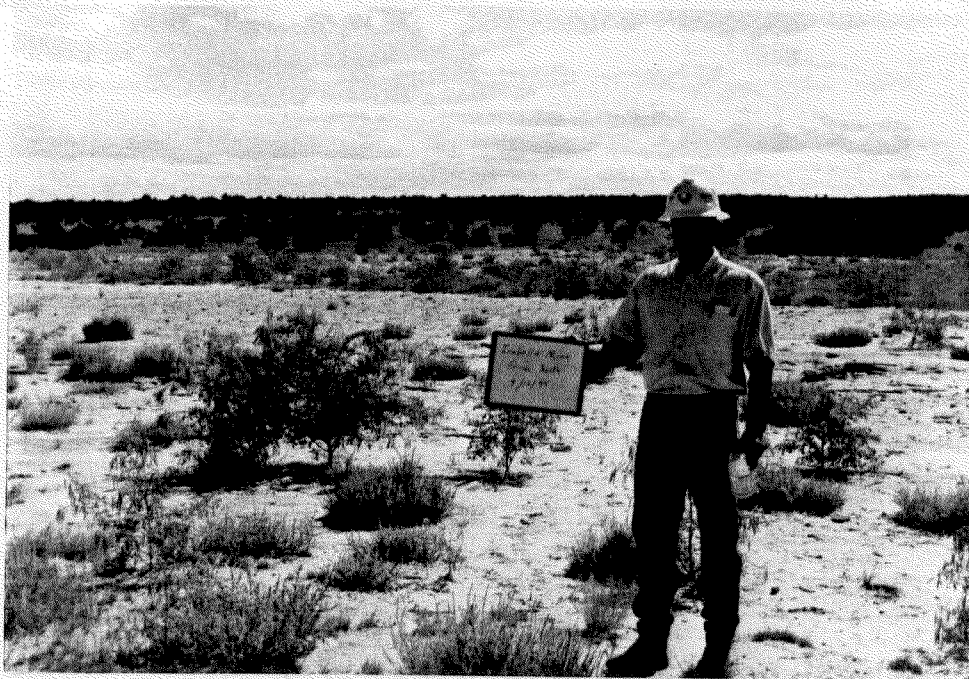
Again, the mine site had been grazed by livestock and wildlife. Similarly, vegetation showed signs of drought stress. Line-intercept transects indicated that vegetation cover was approximately 15 percent (Young, 1995). Results of vegetation measurements are presented in Table VII. Because of the lack of plant cover, this site is not recommended for release.

Isabella Mine, From North, 9/12/95

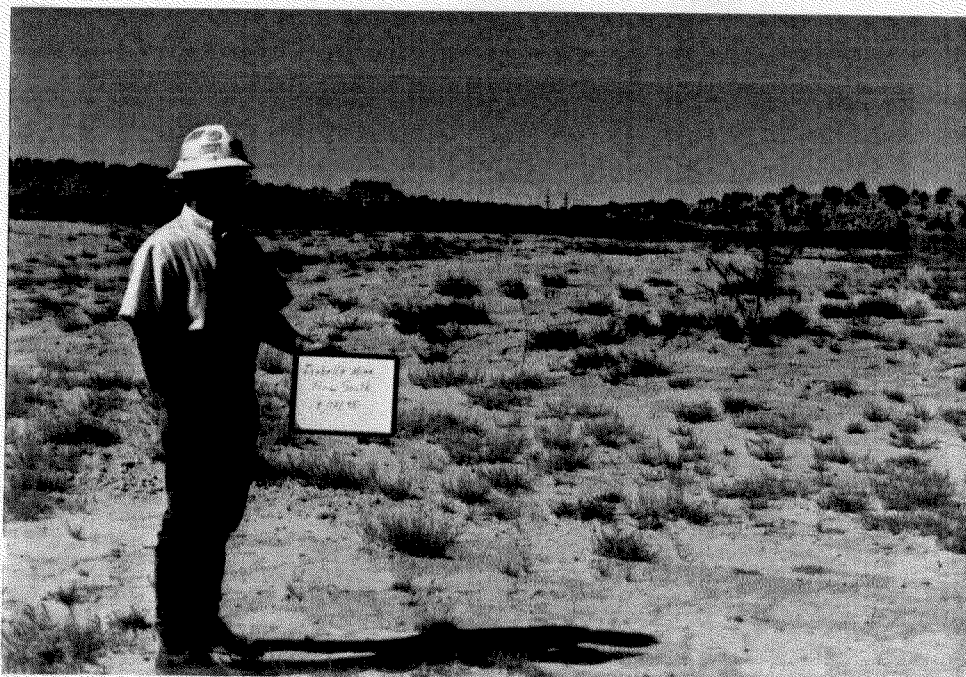
Isabella Mine, From South, 9/12/95

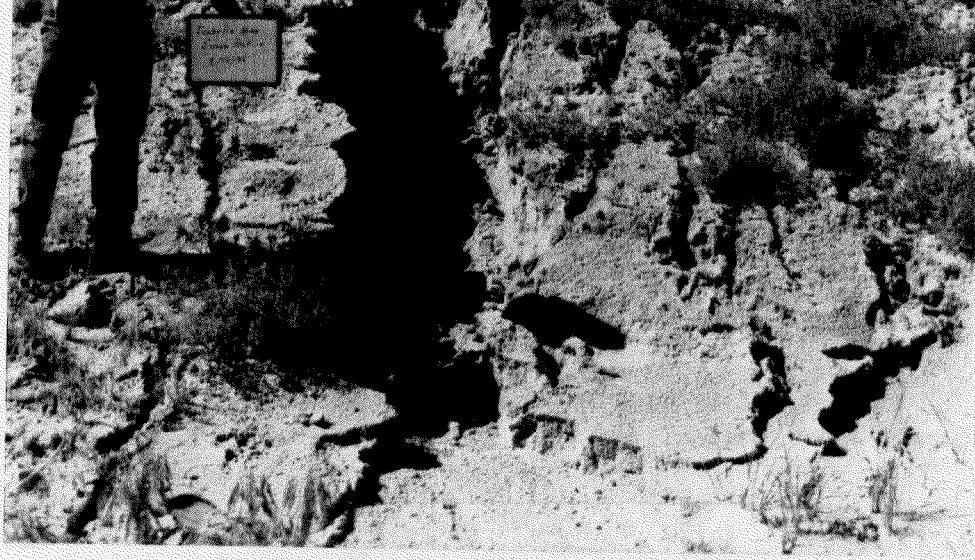
Isabella Mine, Erosion Feature, 9/12/95

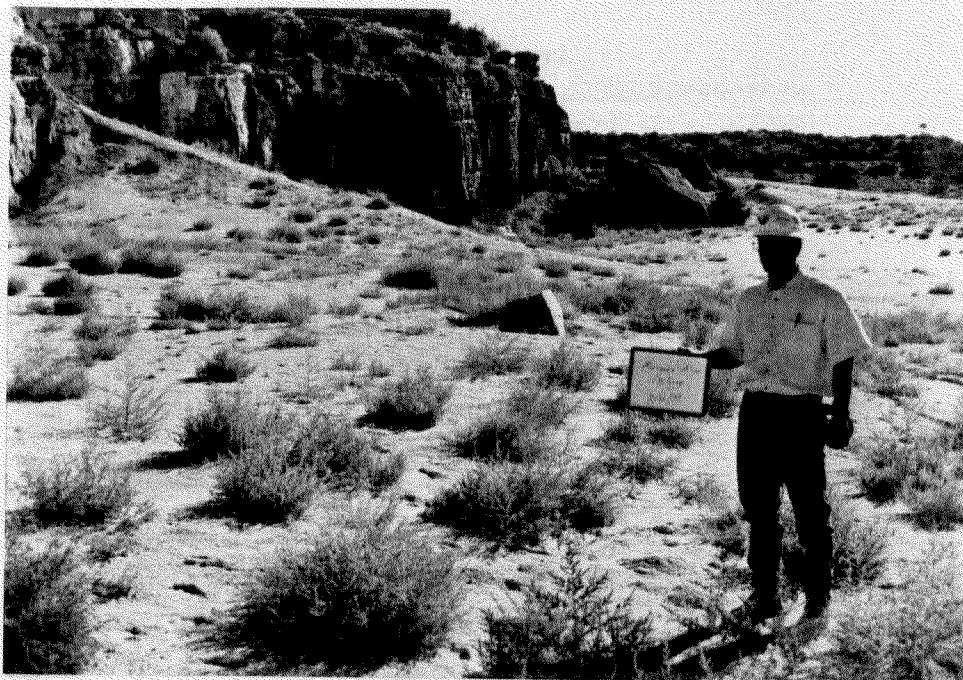
Topsoil depths across the site were greater than 12 inches, but consisted entirely of windblown sand. This area was essentially barren with most of the seed and mulch blown away before vegetation could be established. Native species such as Indian ricegrass (*Oryzopsis hymenoides*), from adjoining areas were starting to invade the disturbance area (Young, 1995). Because of the obvious lack of plant cover at the site no transects were attempted. Staff does not recommend release of this site.

Marquez Mine, Reclaimed Declined Shaft, 9/12/95

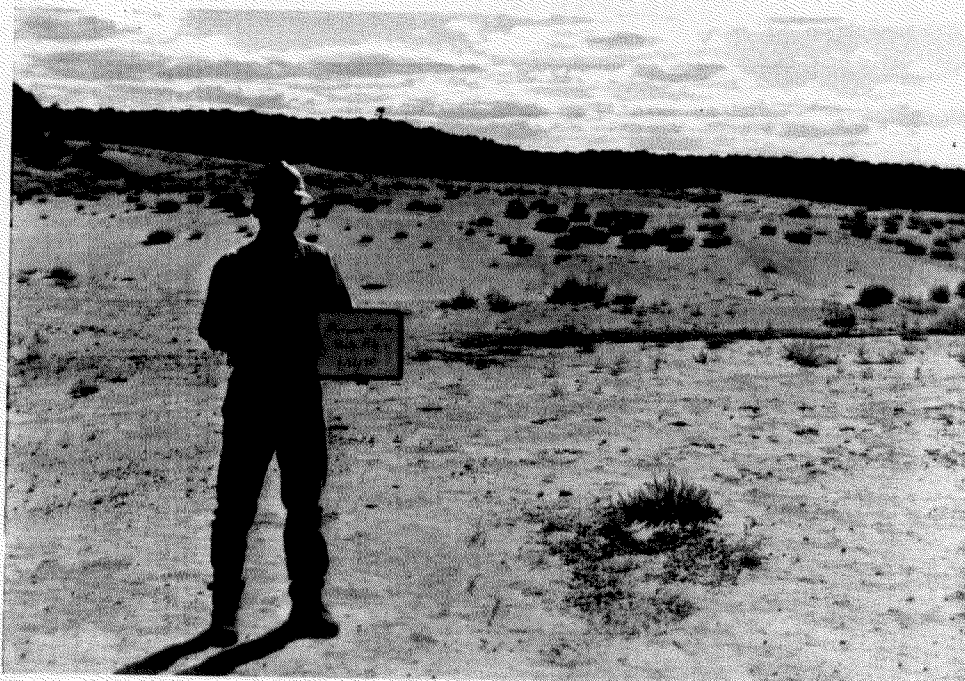
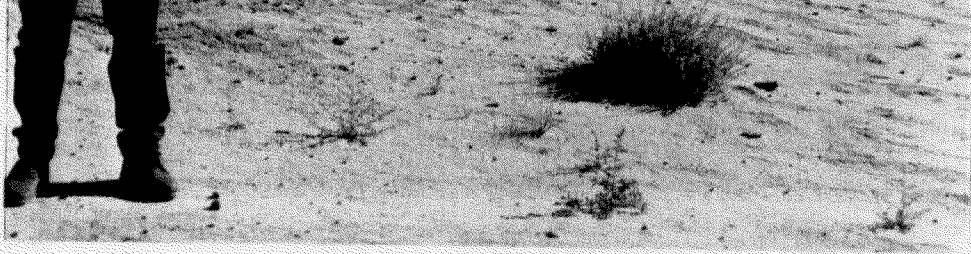
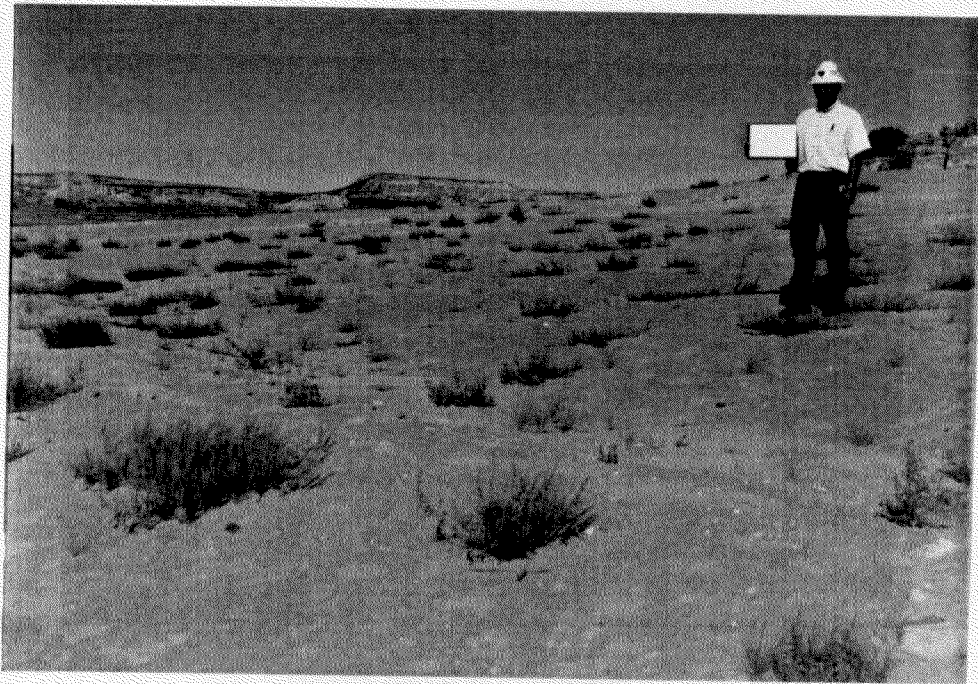
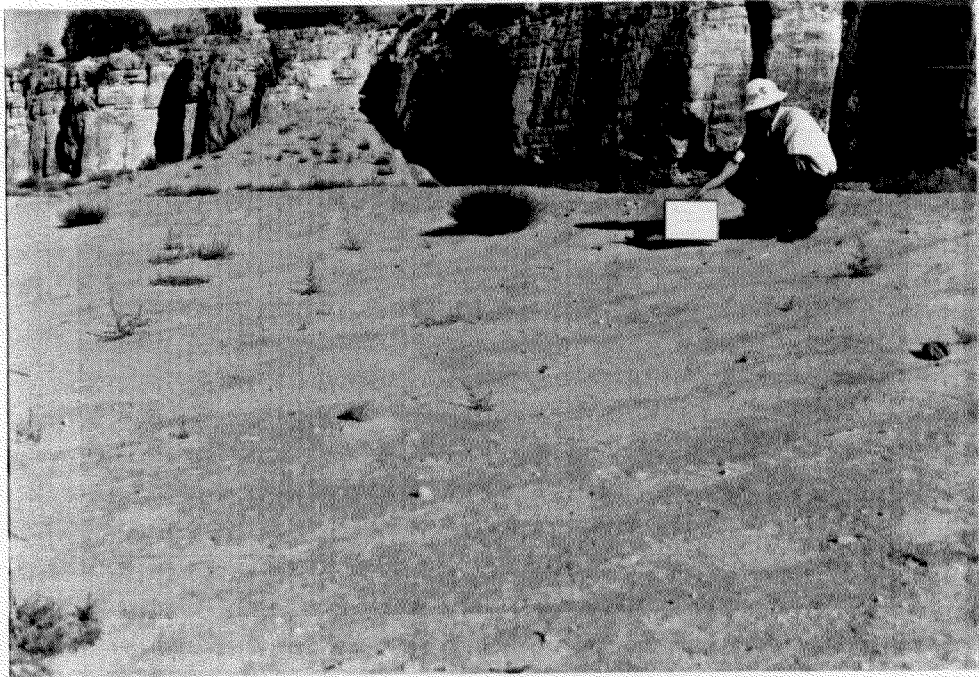
Marquez Mine, Waste Pile, 9/12/95

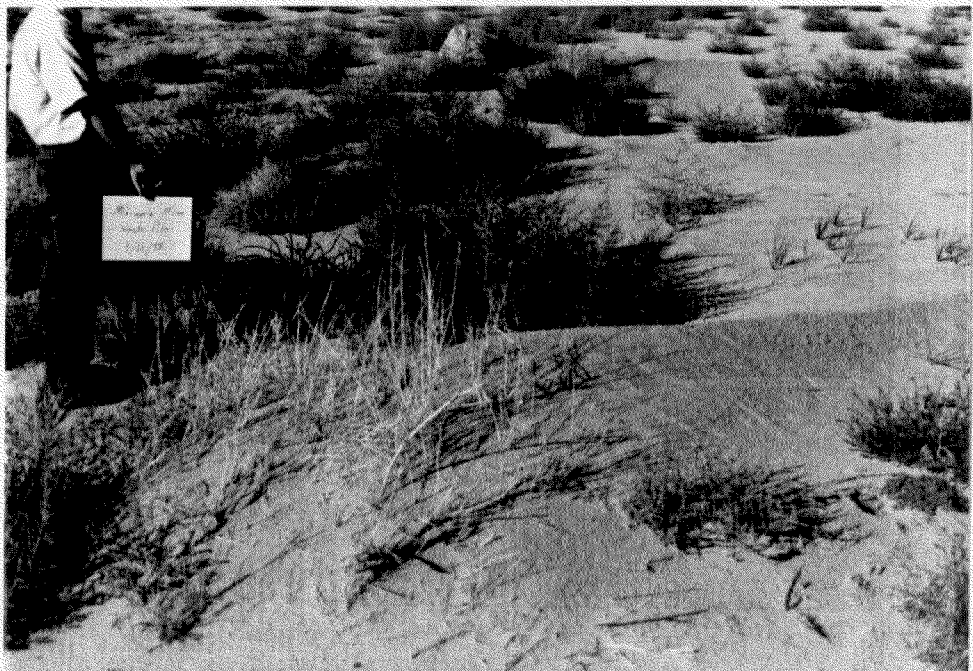
Marquez Mine, Sand Dune, 9/12/95

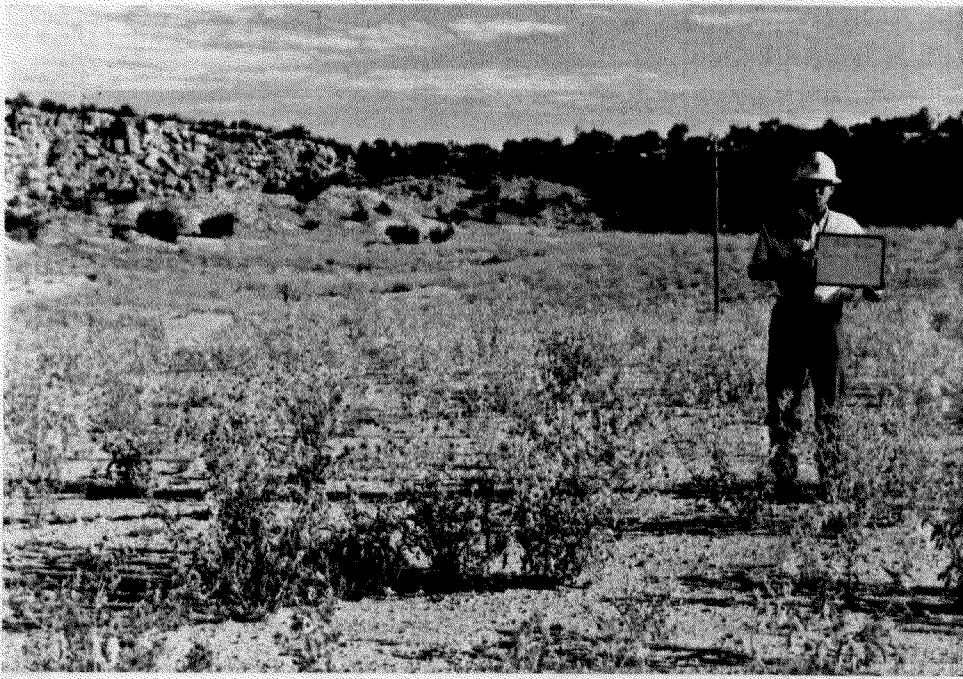
Topsoil depths across the site were approximately 4 inches. Line-intercept transects indicated that perennial vegetative cover was approximately 31 percent. The results of these vegetation measurements are presented in Table VIII.

Poison Canyon Mine, Middle Looking North, 9/12/95

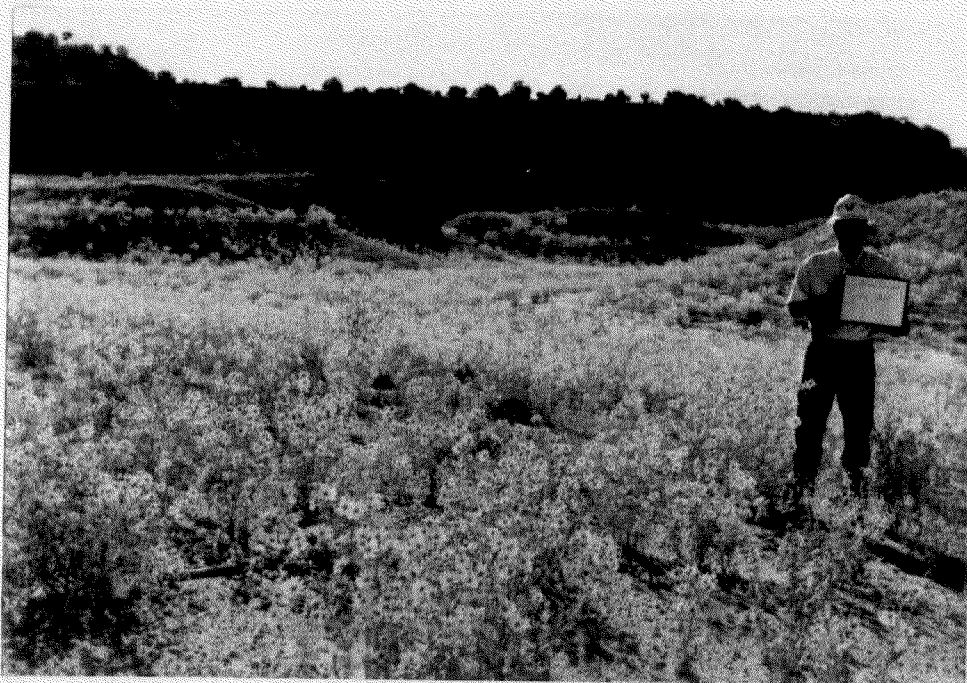
Poison Canyon Mine, Middle Looking East, 9/12/95

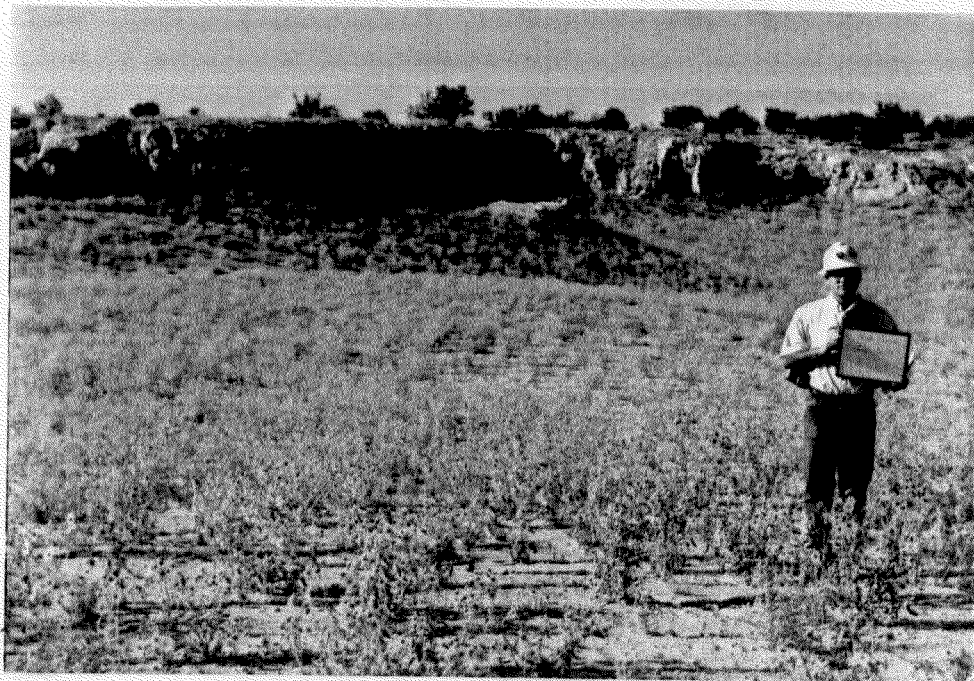
Poison Canyon Mine, Middle Looking South, 9/12/95

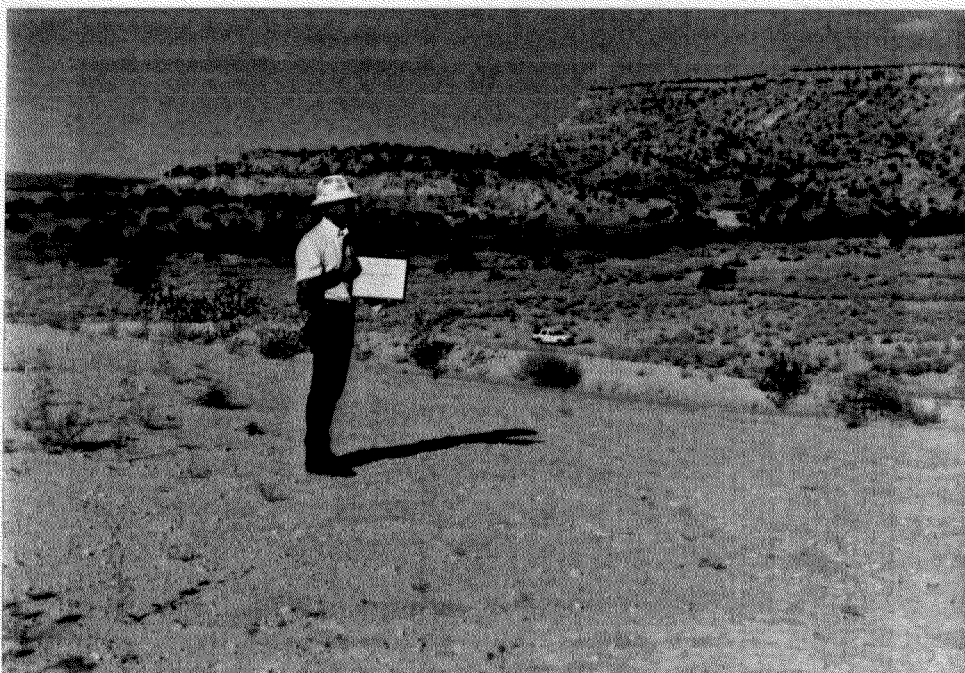
Poison Canyon Mine, Middle Looking West, 9/12/95
